Good practices on built heritage conservation/restoration

Restoration of Valdemar's Wall, Danevirke

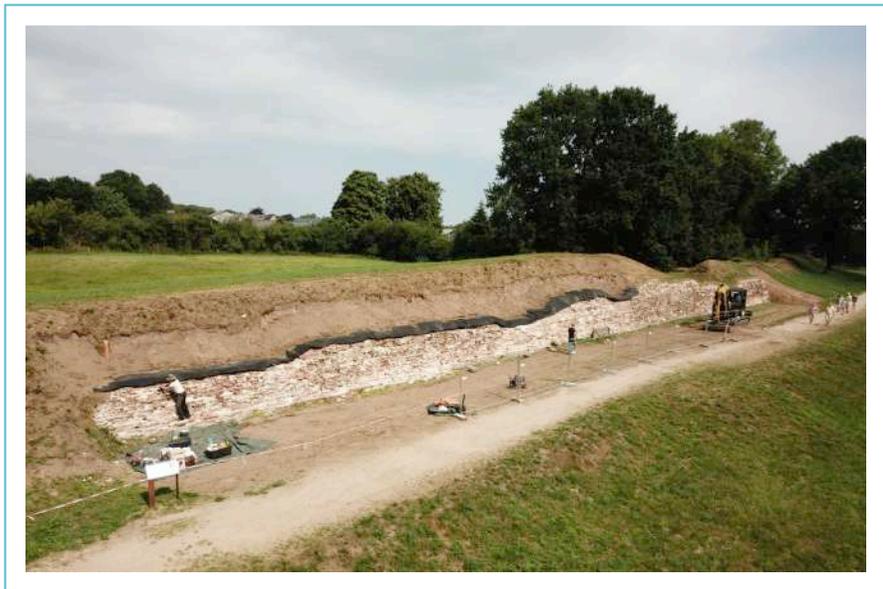
Image No. 3, Protective measures in August
© ALSH

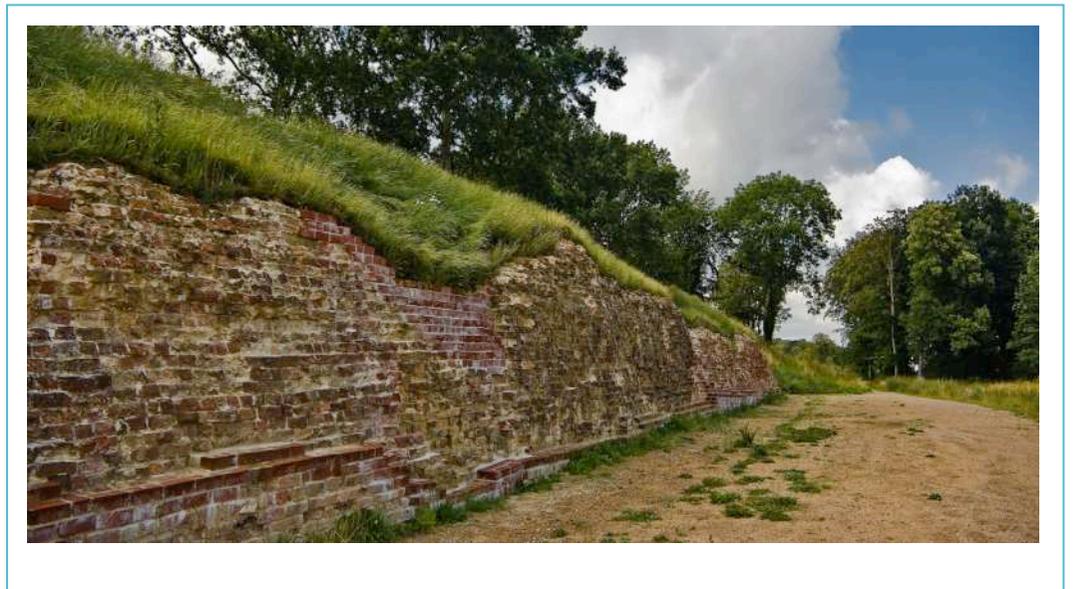
Image No. 4, Valdemar's Wall after the conservation in 2009.
© ALSH/Foto: Michael Lang

The first restoration measures were taken in 2006 and 2008/2009. These included installing rear drainage in the rampart behind the wall ruins, applying a layer of sealing material (Dernoton®) on the coping and reinforced parts of the wall base, and individual areas near the coping with custom-made bricks (as a “sacrificial layer”). Since 2013, relevant institutions, such as the District of Schleswig-Flensburg as the owner and the Schleswig-Holstein State Office for the Preservation of Monuments, have been consulted to plan further conservation measures.

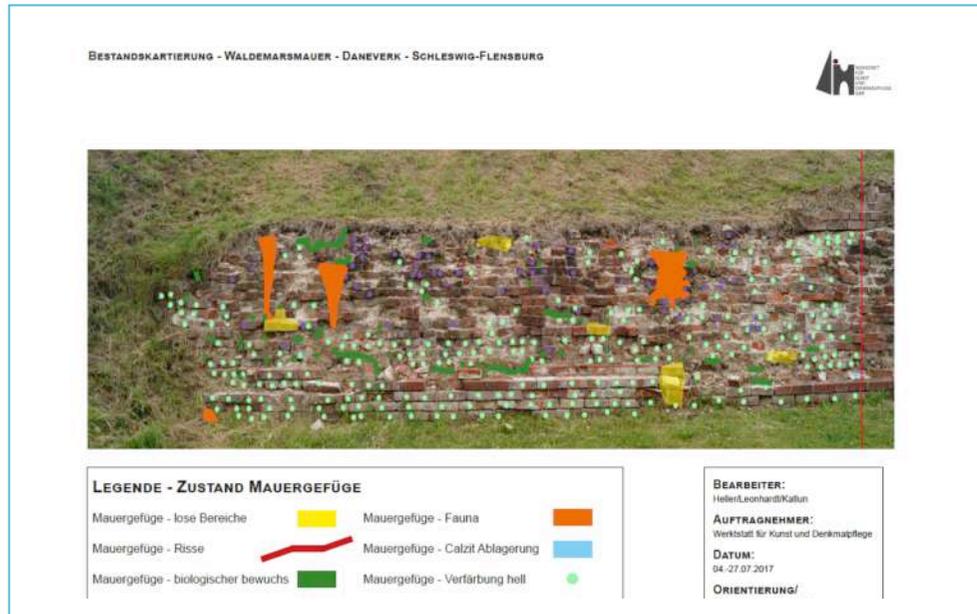
Image No. 5, Excerpt from the conservation concept, mapping the state of conservation.

The restoration concept includes a precise mapping of both the original bricks and the new bricks laid in the course of the restoration measures, as well as an analysis and a list of brick formats and mortar used so far. Comprehensive photographic documentation, as well as photogrammetric and 3D images of the wall taken over several years.

Recent analyses identified harmful salts, which are exacerbated by moisture, as a major factor contributing to the brickwork’s loss of structural fabric and stability. Other factors include frost damage, humification, animals and plants entering the wall structure and improper visitor behaviour. The analysis of the previous measures, as well as the provisional stabilisation measures implemented in 2017 and 2018 have made it possible to accurately determine the effects of the old and new mortar on the wall. The measures aim at reducing the formation of harmful salts to a minimum.

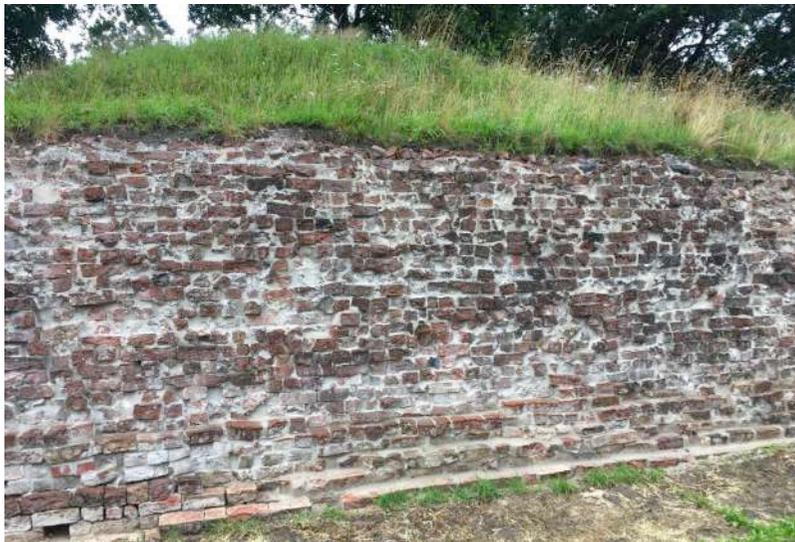
*Image No. 7, Restored brickwork, July 2020.
© ALSH.*

The restoration measures were completed in mid-October 2020. They were aimed at fully preserving the present condition of the brickwork. To this end, dirt, humus, plant remains, animal nests and other deposits had to be removed from the wall. All previously removed original bricks worth preserving were put back into their original position and reintegrated into the brickwork. Damaged subsequent mortar additions were removed and the original grout was reinforced. Fillings of endangered areas were made to achieve long-term stability. Cracks and flaws were closed exclusively to repair existing and prevent further damage.

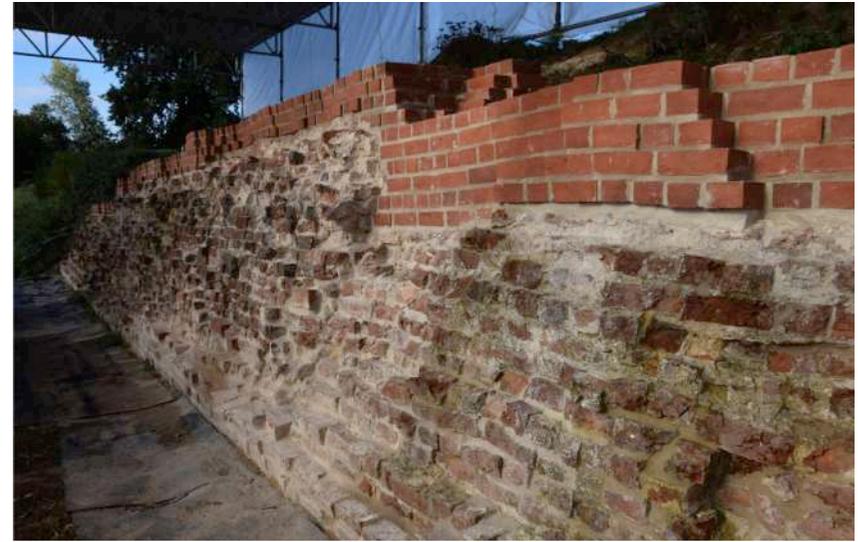
*Image No. 8, New sacrificial layer on top of the coping,
October 2020. © ALSH.*

In the 2018 expert workshops, the long-term conservation and presentation of the coping and various examples of other structures were discussed against this background. Following pre-analyses and expert discussions in July and August 2020, laying a new brick coping to serve as a sacrificial layer ultimately seemed to be the best solution to protect the wall from weather, and ensure the

long-term stabilisation of the fragile upper wall layers, and the entire wall structure. During implementation, it turned out that at least two to three layers had to be applied to keep the sacrificial layer stable and create a protective layer of uniform thickness. Compared to other coverings, this sacrificial layer is expected to more effectively prevent soil from sliding down, animals and plants from entering the wall structure from above and extreme weather effects on the original layers. A steep wall front prevents moisture from entering the brickwork from above and flowing down its front.

The sacrificial layer on top of the coping was designed to match the irregular pattern of the ruined surface and fit into the existing structure, while still being clearly recognisable as a modern addition. Following a field test, the design of the sacrificial layer was seen by the expert panel as a necessary compromise between minimizing visual change to the monument, and conserving it as far as possible. The sacrificial layer is reversible and can be further adapted if better ways for covering the coping are found in the future. Since the wall is stronger and broader towards the base, the thin protective layer on top of the coping is not predicted to involve any problems concerning the structural stability, of either individual sections or the entire wall. The sacrificial layer was completed at the end of October 2020.

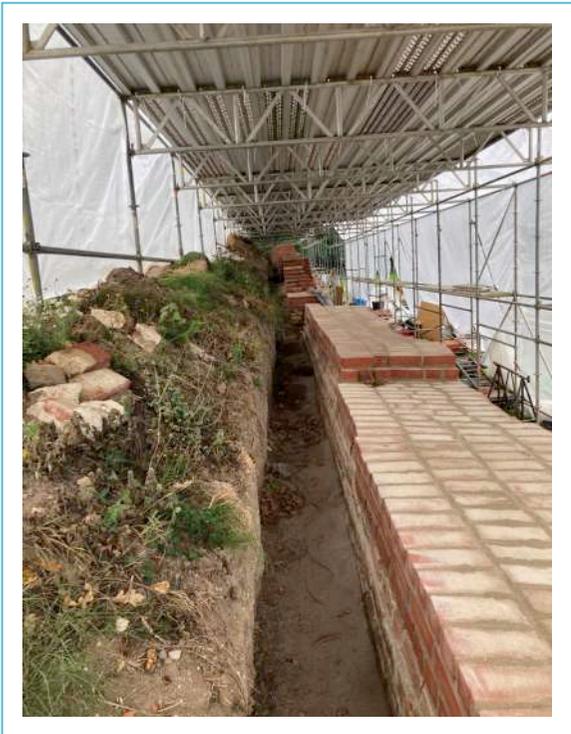
Image No. 9, Drainage area behind the wall, October 2020. © ALSH

In the course of examining drainage, trial pits were dug at the wall base to determine the dimensions of the foundations and to locate the drainage directly in front of the wall.

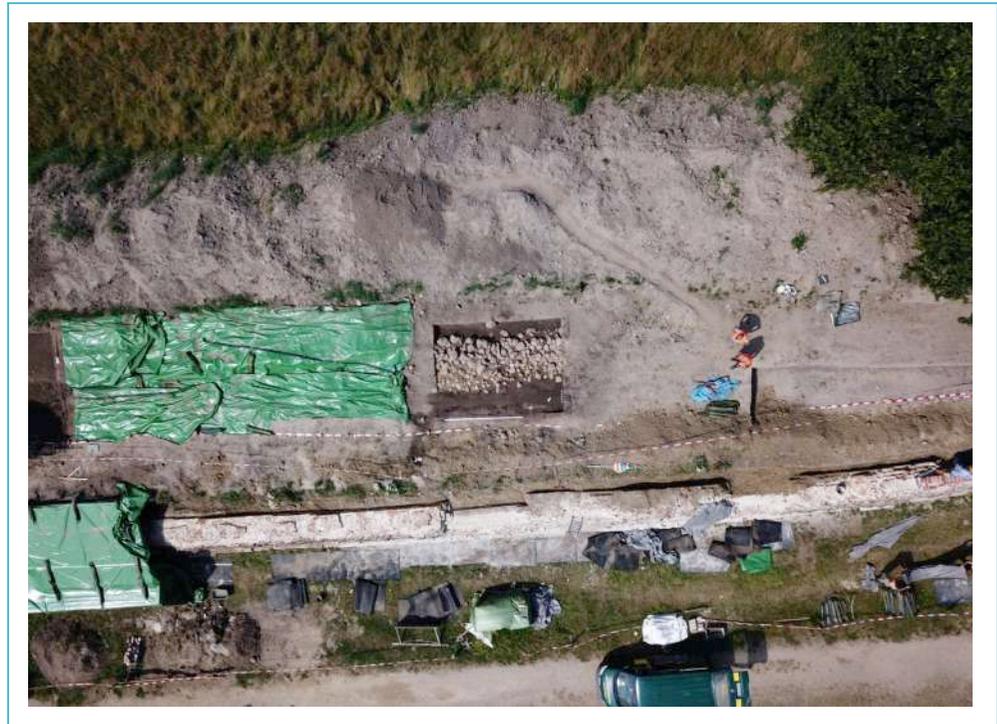
Image No. 10, Investigation area north of Valdemar's Wall with exposed top of the Fieldstone Wall, August 2020. © ALSH

Following the work on the rampart embankment behind Valdemar's Wall to uncover the drainage system, an archaeological examination was conducted. Structures of the early medieval Fieldstone Wall were uncovered in the process. The exact course of the wall at this position has not yet been determined.

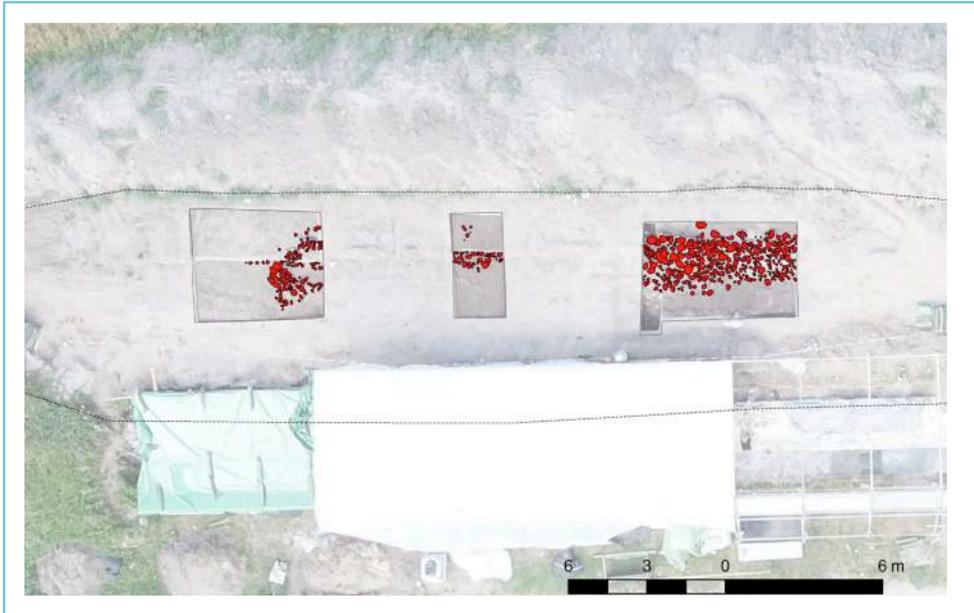
Image No. 11, Course of the Fieldstone Wall behind Valdemar's Wall (red marking). © ALSH, Foto: L. Hermannsen.

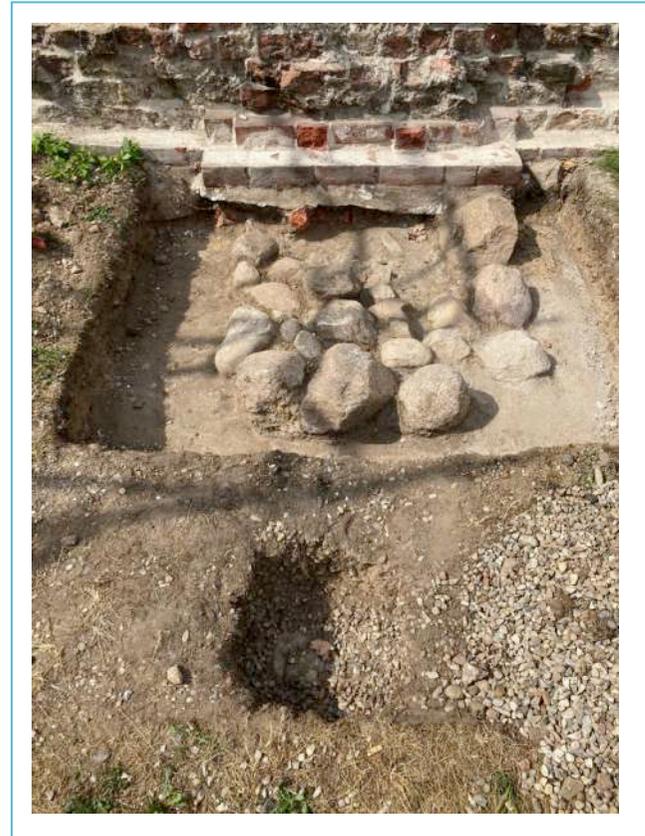
Image No. 12, Field stone foundation of Valdemar's Wall and position of the drainage in front of the wall, August 2020. © ALSH

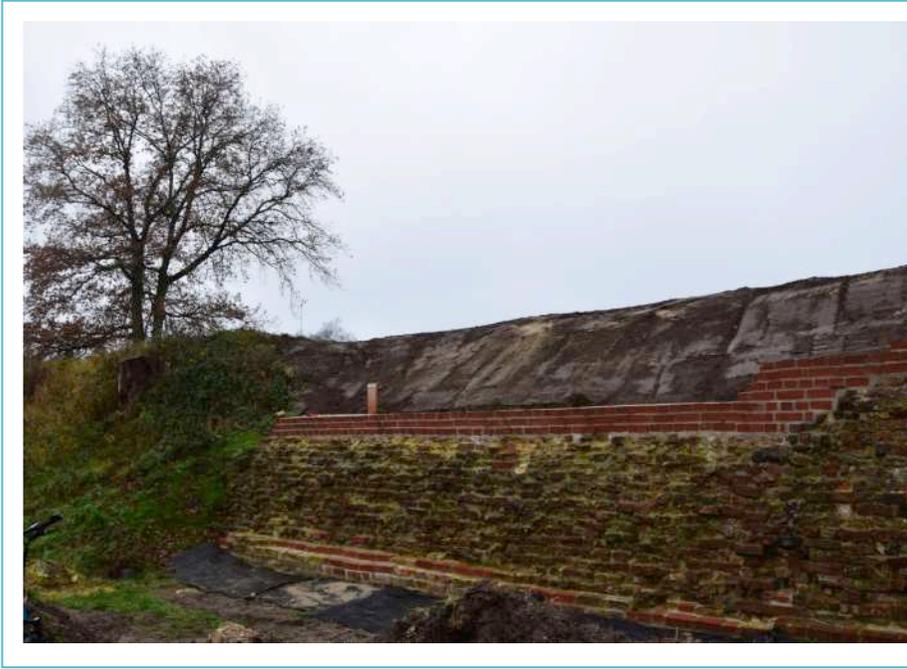
Image No. 13, Front of Valdemar's Wall with the new sacrificial layer on top of the coping and the still-barren rampart behind it, December 2020. © ALSH

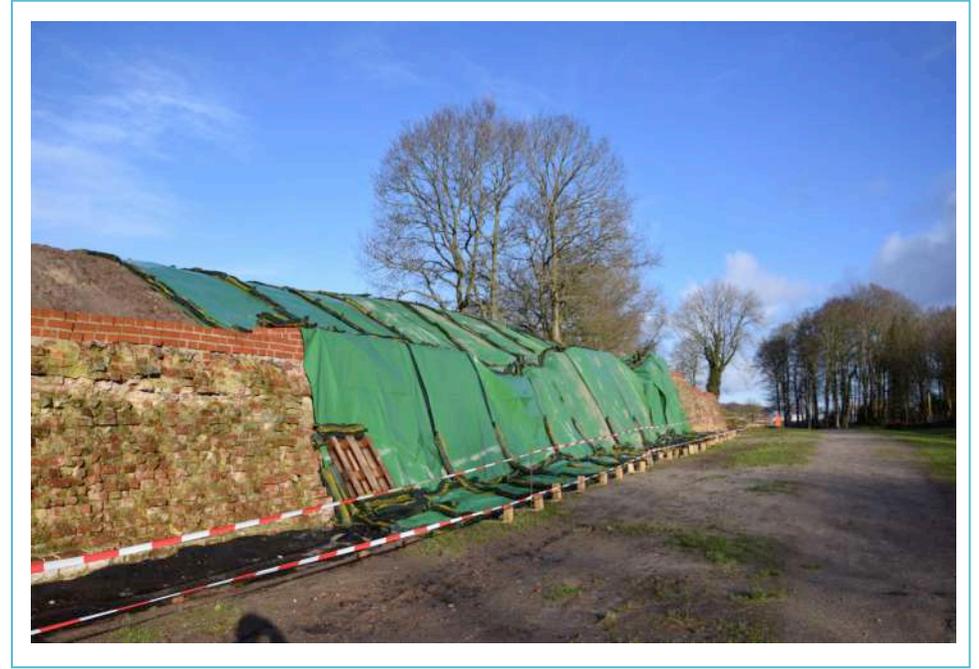
Image No. 14, Valdemar's Wall, winter covering, January 2021. © ALSH

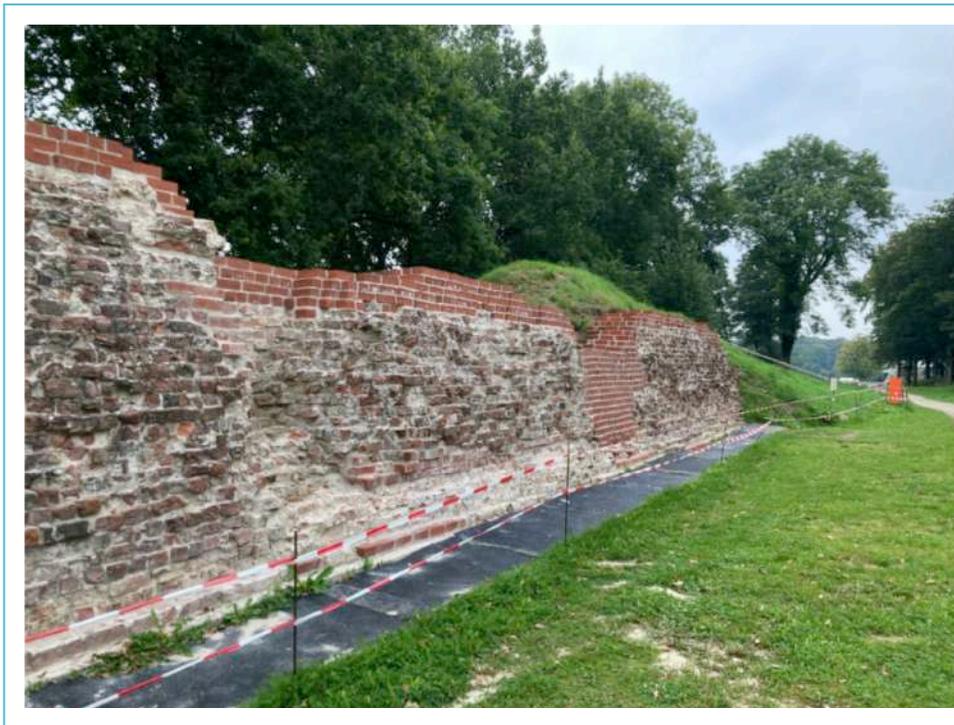
Image No. 15, Valdemar's Wall, September 2021 after conservation. © ALSH

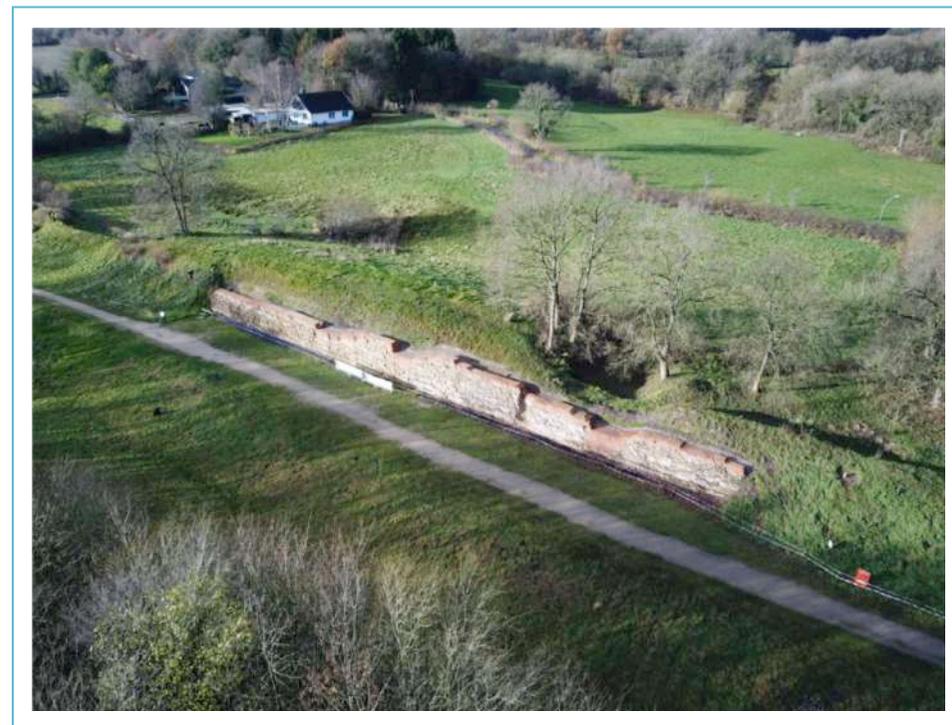
Image No. 16, Valdemar's Wall, September 2021 after conservation. Bird's eye view. © ALSH
