**B**ALTIC REGION HERITAGE COMMITTEE

## Good practices on built heritage conservation/restoration

*The south sacristy of the Church of St George the Martyr and the Bernardine Friary, Kaunas.*

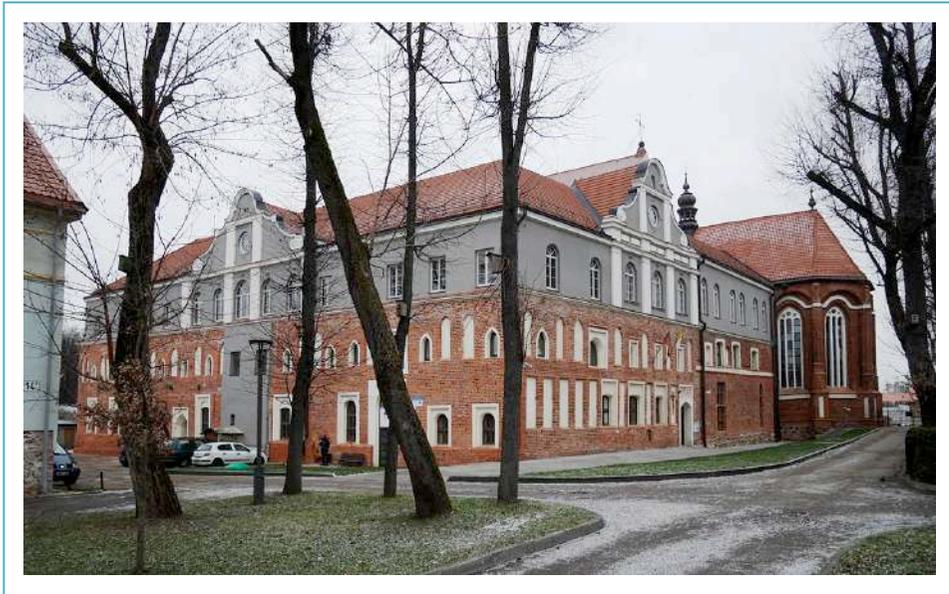
*Image No. 1, The Church of St George the Martyr in Kaunas.  
The sacristy can be seen on the right, next to the church.  
Photograph: Aurimas Švedas, 2017.*

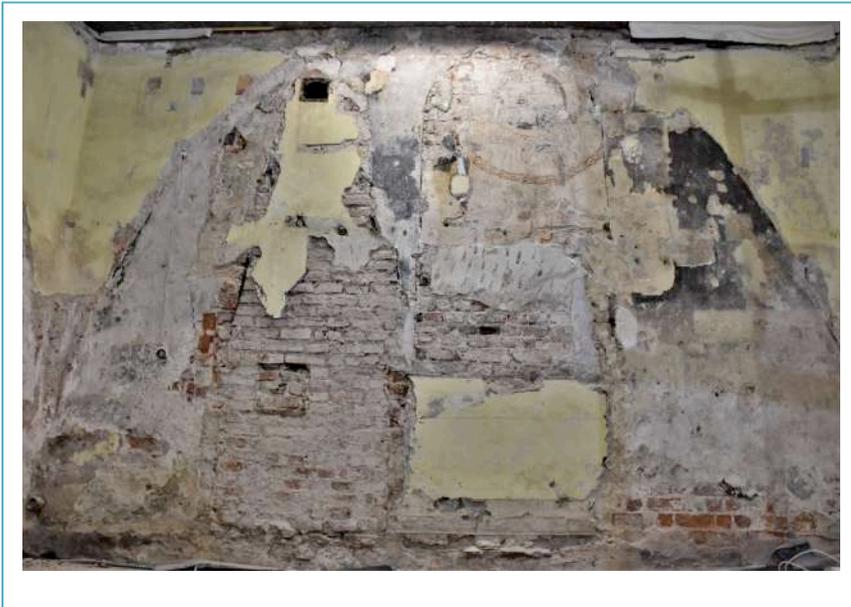
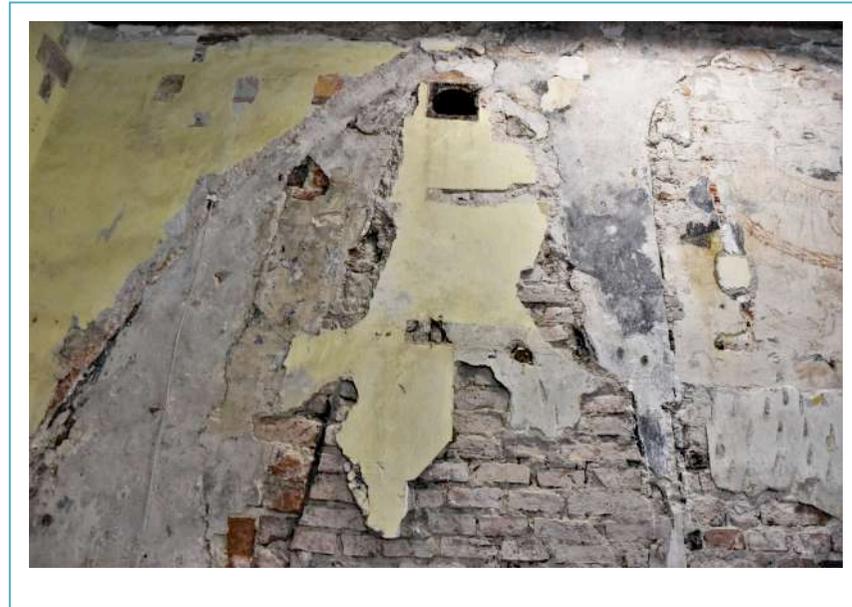
*Images No. 2, 3, The south wall of the sacristy before its conservation.*

*On the left, the position of the former fireplace is visible. Slightly to the right of the centre is a bricked-up window with an earlier Gloria, revealed during previous investigations, with a hierogram of the Virgin Mary (late 16th to early 17th century). Photograph: Lina Katinaitė, 2016.*

In 2016, major conservation and restoration work began on the polychromatic walls of the south sacristy. Until then, the room had not been used or heated for a long time, so it was very humid, and had been damaged by biological contamination. The walls have been repainted many times and replastered two or three times. The plaster caused many holes to be drilled, there are deep cracks, tears and dents, some openings have been bricked-up, and the plaster has come off in places. There is no plaster on the lower

parts of the walls, and the bare masonry of bricks and stones has been exposed. Higher up, the plaster has survived in places, and bits of wall paintings from different periods can be seen on it, laid on top of each other, covered with dirt and crumbling.

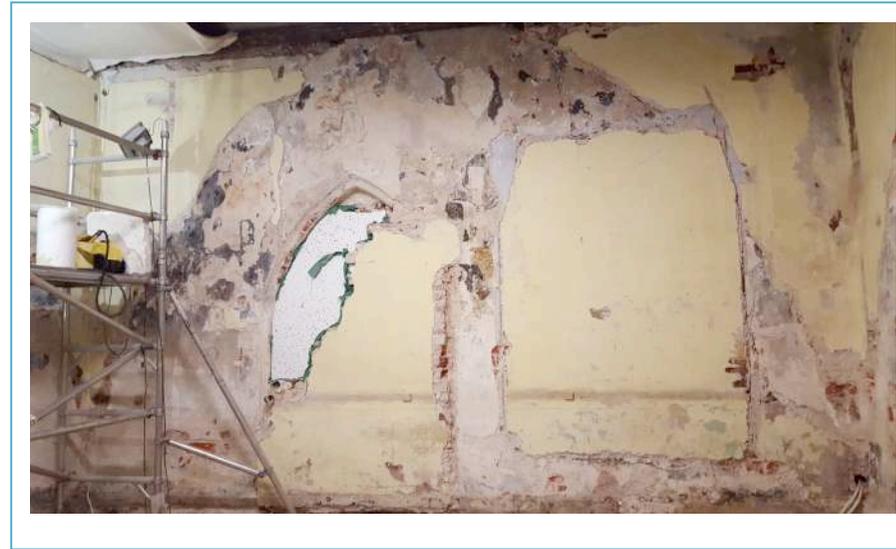
*Image No. 5, The north wall during the conservation work.*

*On the left is the still-uncovered pointed doorway to the northern sacristy. On the right is a rectangular walled-up space for a wall cabinet. Photograph: Lina Katinaitė, 2016.*

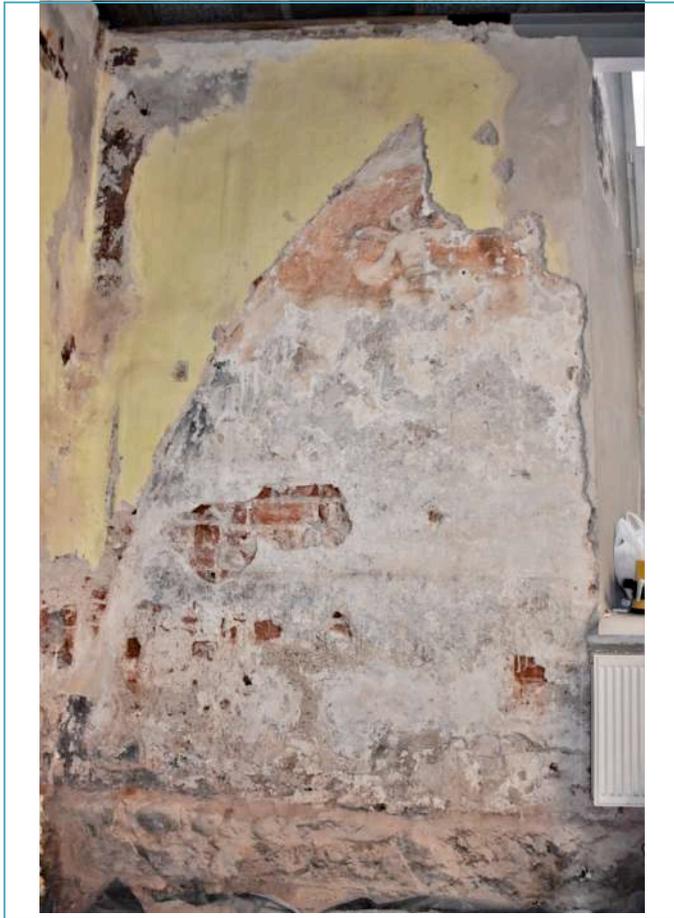
*Image No. 6, The left side of the east wall during conservation work.  
In the lower part of the wall, a horizontal decorative strip (late 15th to 16th century) is visible.  
In the upper part, there is a layer of a High Baroque painting (1669). Photograph: Lina Katinaitė, 2016.*

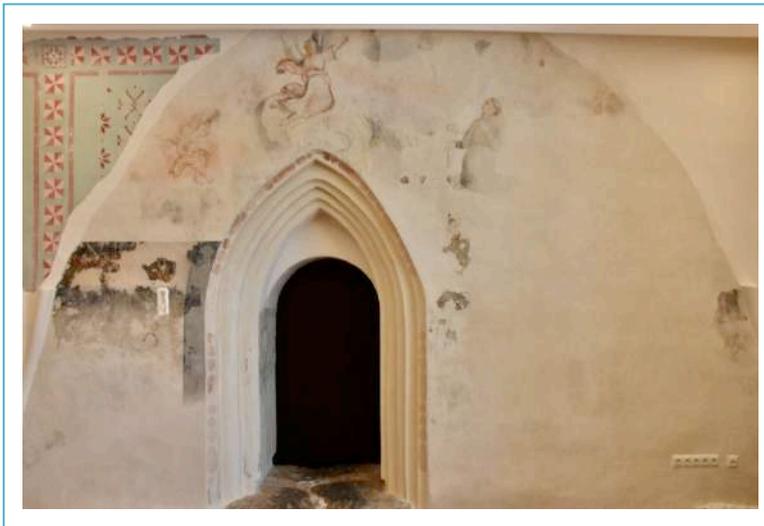
*Image No. 7, The north wall after its restoration.*

*The exposed Gothic portal with a late 16th to early 17th-century wall Crystal painting.*

*On the left is a 'black' layer (second quarter of the 17th century).*

*In the upper part is a Baroque layer of 'angels' (1669).*

*In the top left-hand corner is a layer of stencil decoration (first quarter of the 20th century). Photograph: Tatjana Purienė, 2020.*

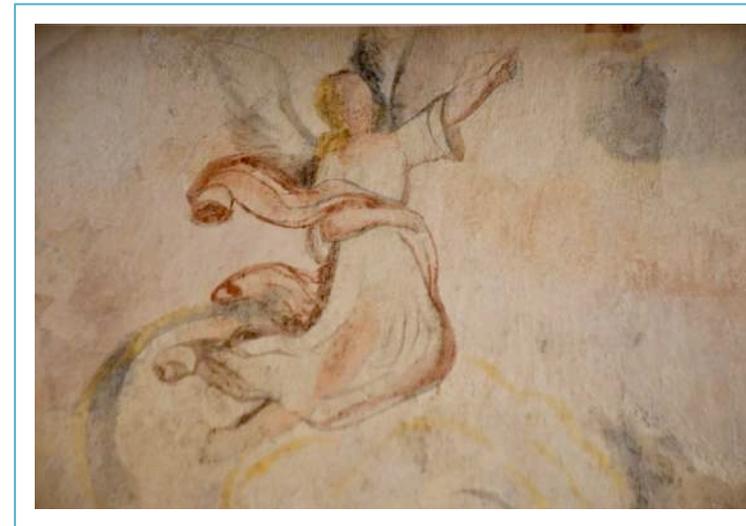
*Image No. 8, Part of the north wall after its restoration.*

*A detail from the scene 'The Angel Shows St Francis the Cup' (1669).*

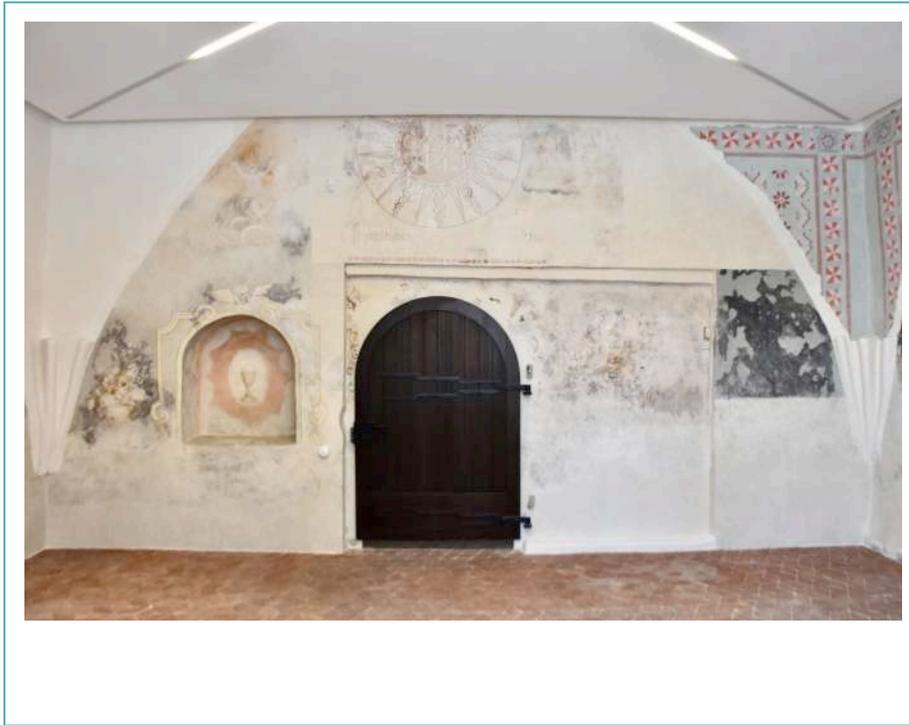
*Image No. 9, The west wall after its restoration.  
 Below the niche, traces of late 15th-century and early 16th-century paintings have been found. In the centre at the top are angels holding The Gloria with a hierogram of Jesus (late 16th to early 17th century). To the right is the 'black' layer (second quarter of the 17th century). The rest of the wall is the 'Baroque' layer (1669).  
 Photograph: Tatjana Puriénė, 2020.*

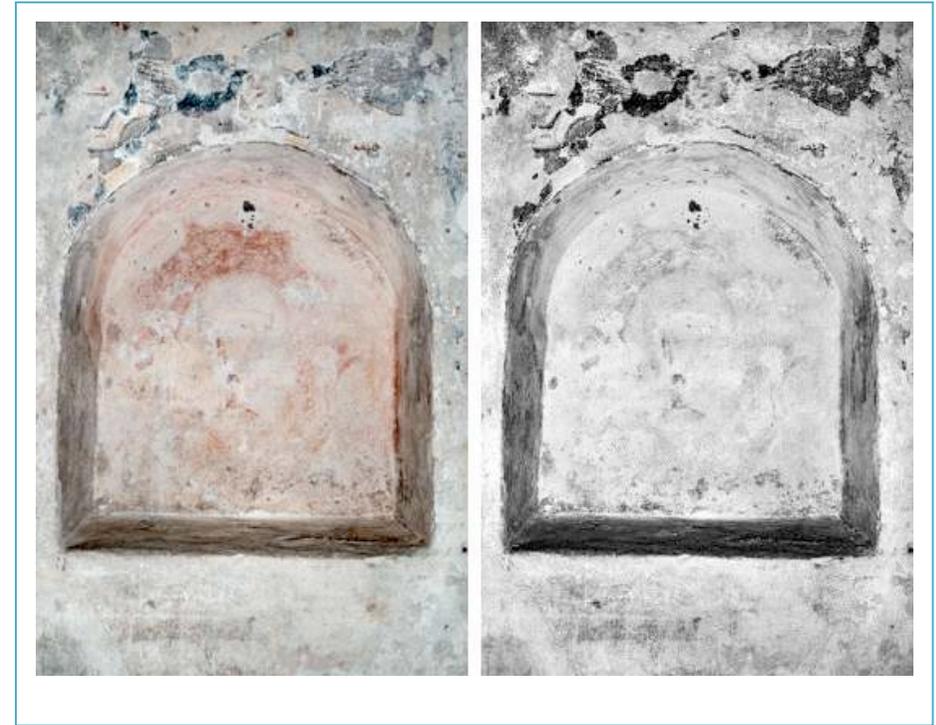
*Image No. 10, Detail of the west wall during its conservation.  
 Scattered photograph and IR photograph (~ 900nm).  
 Photograph: Rapolas Vedrickas, 2019.*

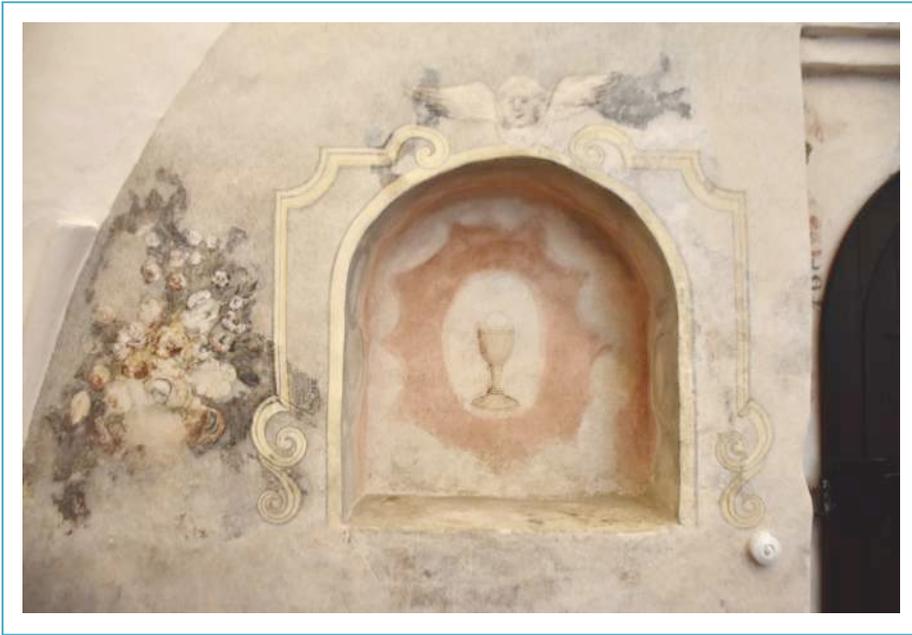
*Image No. 11, Detail of the west wall after its restoration.  
An uncovered niche with a Baroque depiction of the Blessed Sacrament  
(1669).  
Photograph: Tatjana Purienė, 2020.*

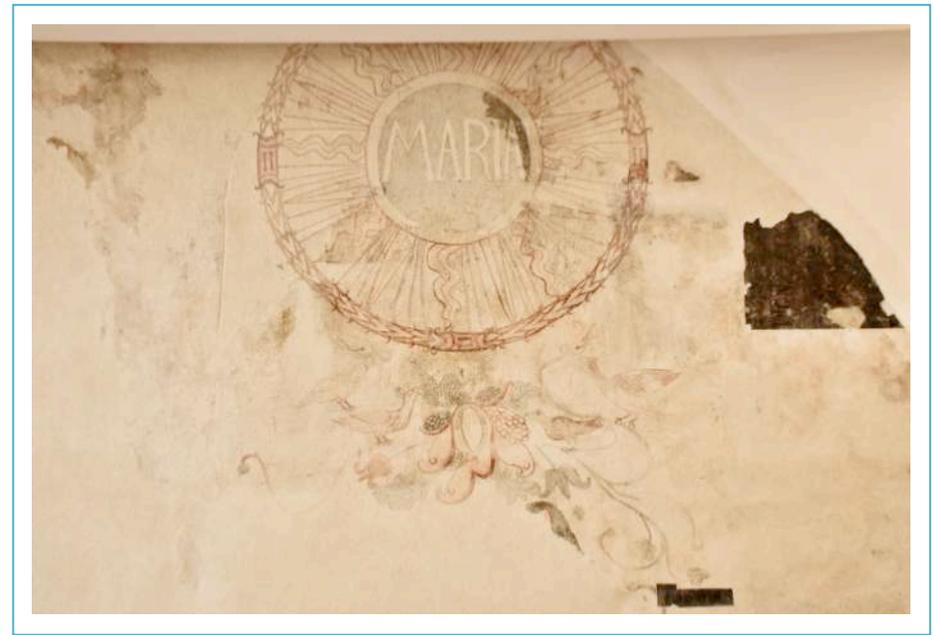
*Image No. 12, Detail of the south wall after its restoration.  
The Gloria with a hierogram of Mary (late 16th to early  
17th century). On the right and at the bottom, fragments  
of text from the 'black' layer have been preserved .  
second quarter of the 17th century).  
Photograph: Tatjana Purienė, 2020.*

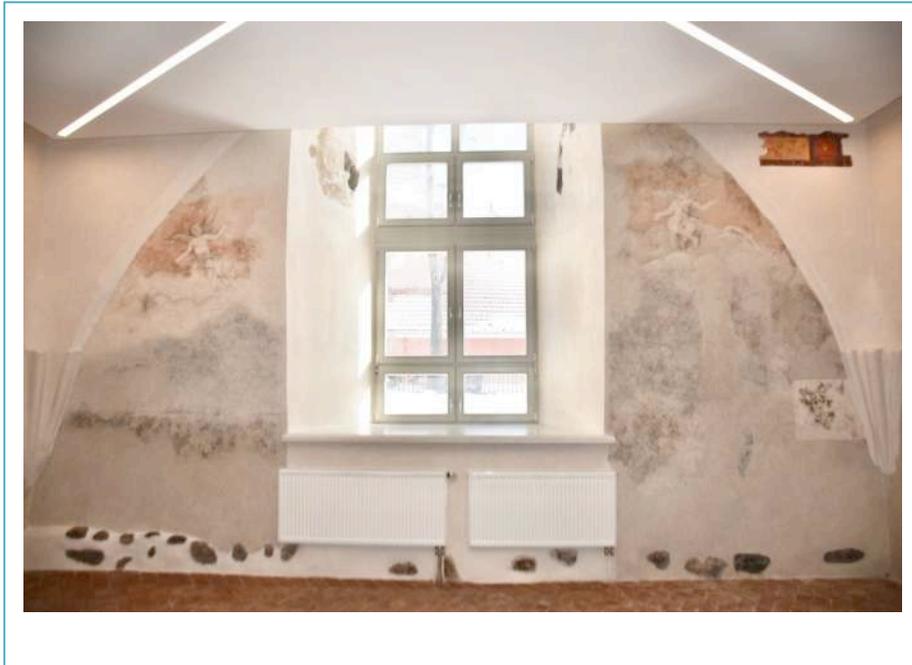
*Image No. 13, Detail of the east wall after its restoration. The uncovered window opening with the painting and the height of the interrupted vaulting can be seen. At the bottom is a stone wall. Above it is a horizontal strip of painting (late 15th to 16th century). At the top is the Baroque layer of 'angels' (1669). In the top right-hand corner, there is an example of stencil painting (1865). Photograph: Tatjana Purienė, 2020.*

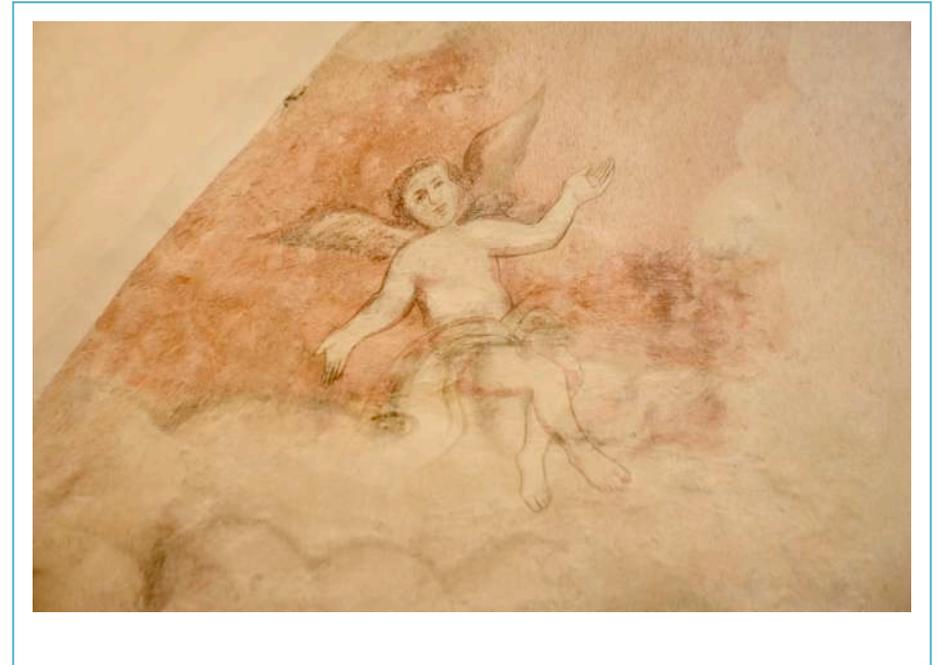
*Image No. 14, Detail of the east wall after restoration. The Baroque 'angel' layer (1669). Photograph: Tatjana Purienė, 2020.*
