Good practices on built heritage conservation/restoration

Wodociąg (Muzeum Łazienki Królewskie w Warszawie) / The Water Tower (Royal Łazienki Museum in Warsaw).

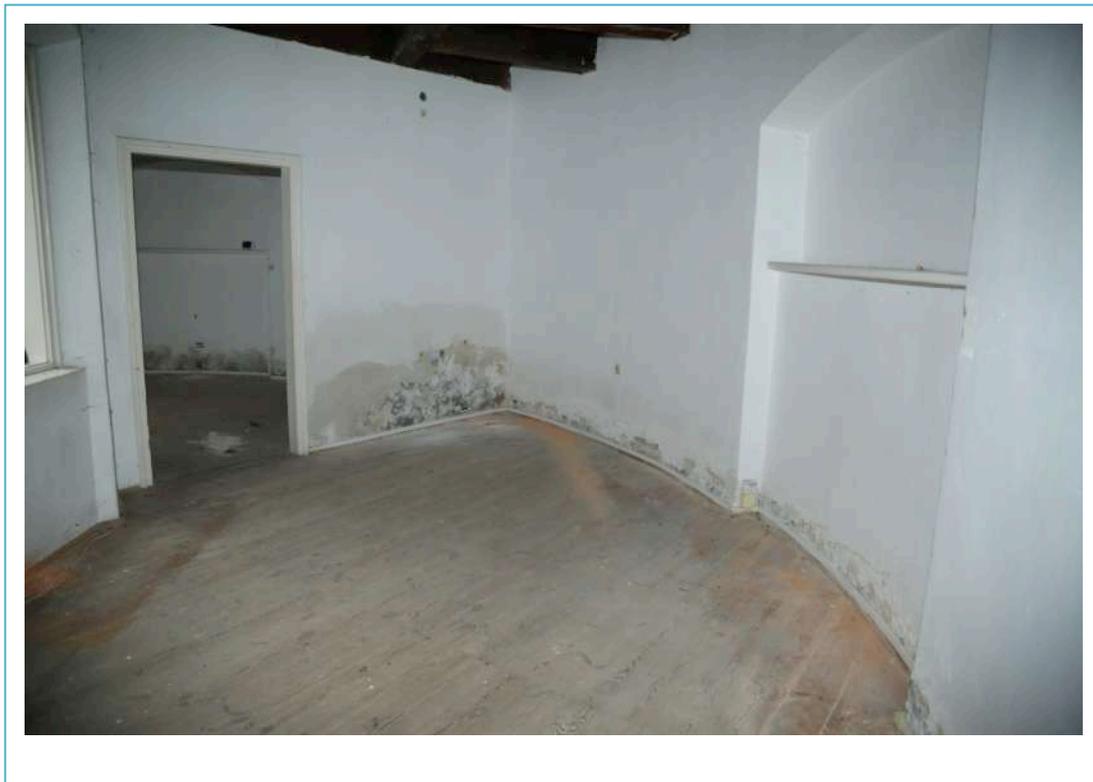
Prior to the project implementation, the facility had not been accessible to visitors due to poor conservation status, mainly caused by high levels of moisture in the walls, resulting in biological corrosion, as well as the lack of appropriate adaptations and protection systems. The architectural details, wall claddings and floors had gradually degraded. As a result of earlier interventions, the original interior layout was changed. Strong chemicals used during previous repair work led to air pollution. An obsolete electrical system, as well as the condition of the wooden structure of ceilings and the roof truss did not ensure safety for visitors.

Image No.3, Ground floor before the conservation, photo by Marta Boguta

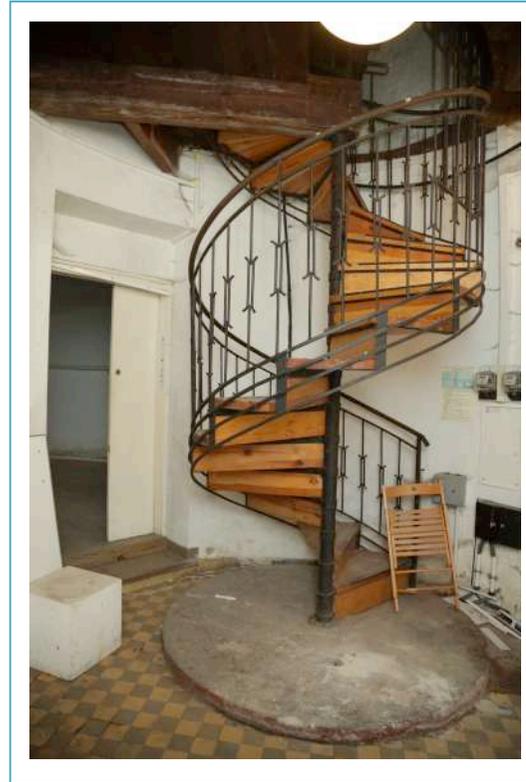
*Image No. 5, Vestibule before the conservation,
photo by Marta Boguta*

amounted to PLN 2,984,070.94. The budget increased during the work due to historical findings of preserved, original elements, which were excavated and secured. In the course of the work, numerous discoveries were made in relation to the original interior design, which following consultations and adjustment of the work programme, allowed among other things to keep the historical layers uncovered and restore the original colours of the walls. The work enabled workers to resolve the issue of moisture in the interiors, without interfering with the historical system of the water reservoir, to eliminate air pollution and protect the building against fire. Eventually, an independent system was implemented to ensure the insulation of the upper part of the building from the reservoir tank; it was adapted to the existing historical membrane made of lead sheet which was preserved. The reservoir's vaults were subjected to conservation and protected without interference with the wall brickwork; conservation measures were also applied to the elevation and the stone and stucco detail in form of cornice with bucraniums and garlands, the plinth and the portico. Moreover, underneath the floor in the vestibule, a wooden gutter was discovered. Despite its extremely poor conservation status, it was preserved to be displayed in its original location. This procedure required an adaptation of the design of the floor and the insulation layers. In the vestibule, we can also see the uncovered and preserved elements of two furnaces.

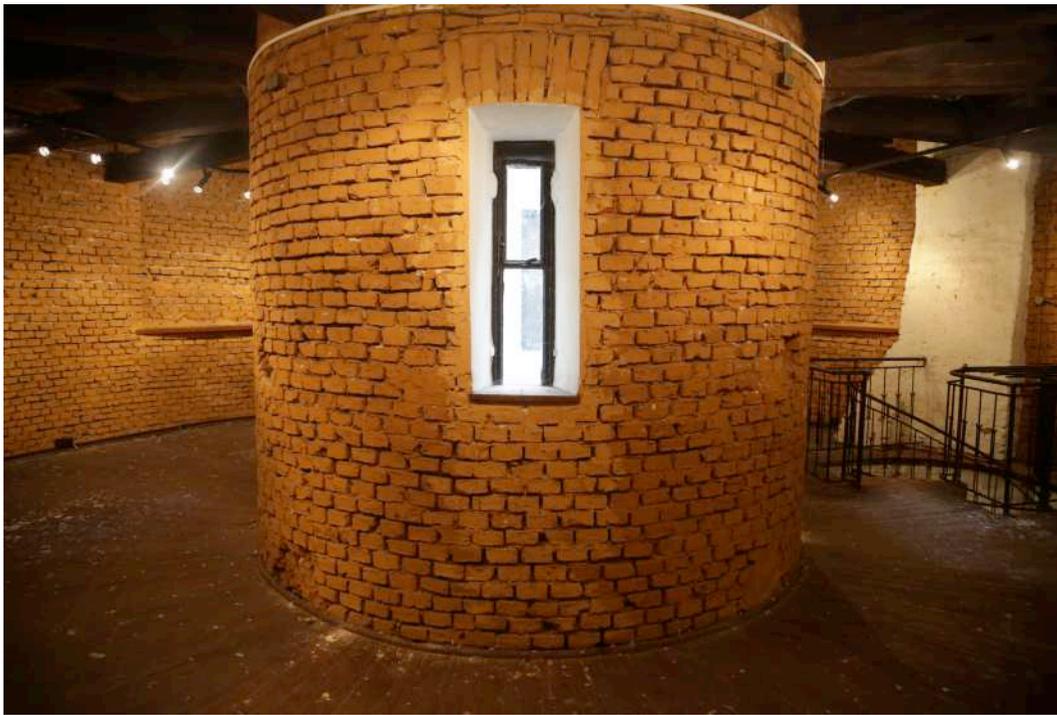
*Images No. 6, 7, First floor before the conservation,
photo by Marta Boguta*

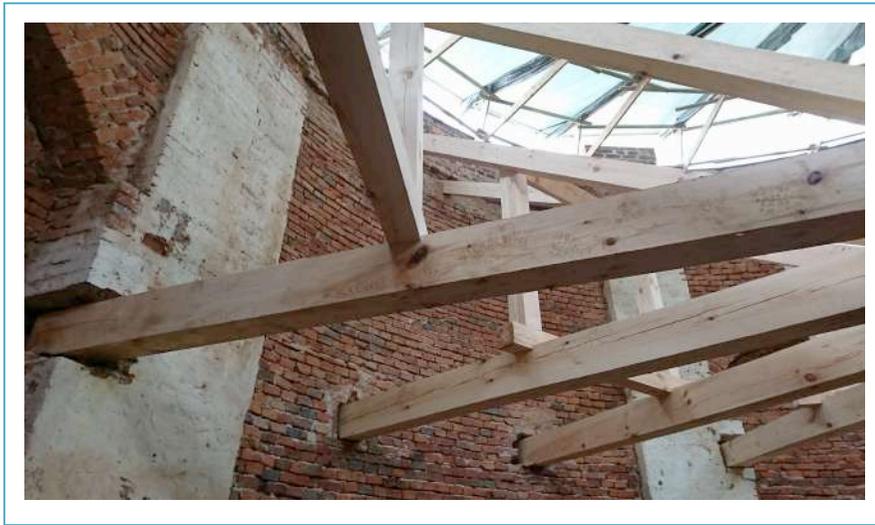
Image No. 8, Roof truss during the conservation, photo by Maciej Czyski

Following the model of the stairs in the Palace on the Isle, cast-iron stairs leading to the first floor of the building were reconstructed. The roof covering and the secondary structure were also replaced, while preserving the original system of water drainage in form of a "funnel".

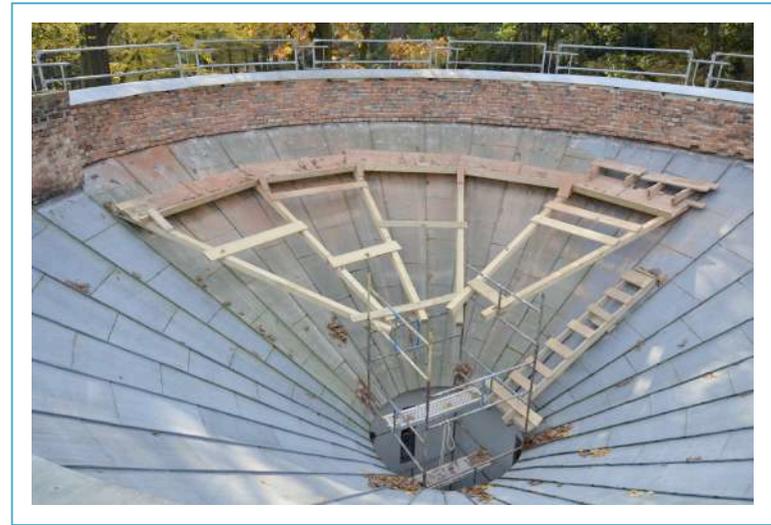
Image No. 9, Roof during the conservation, photo by Maciej Czyski

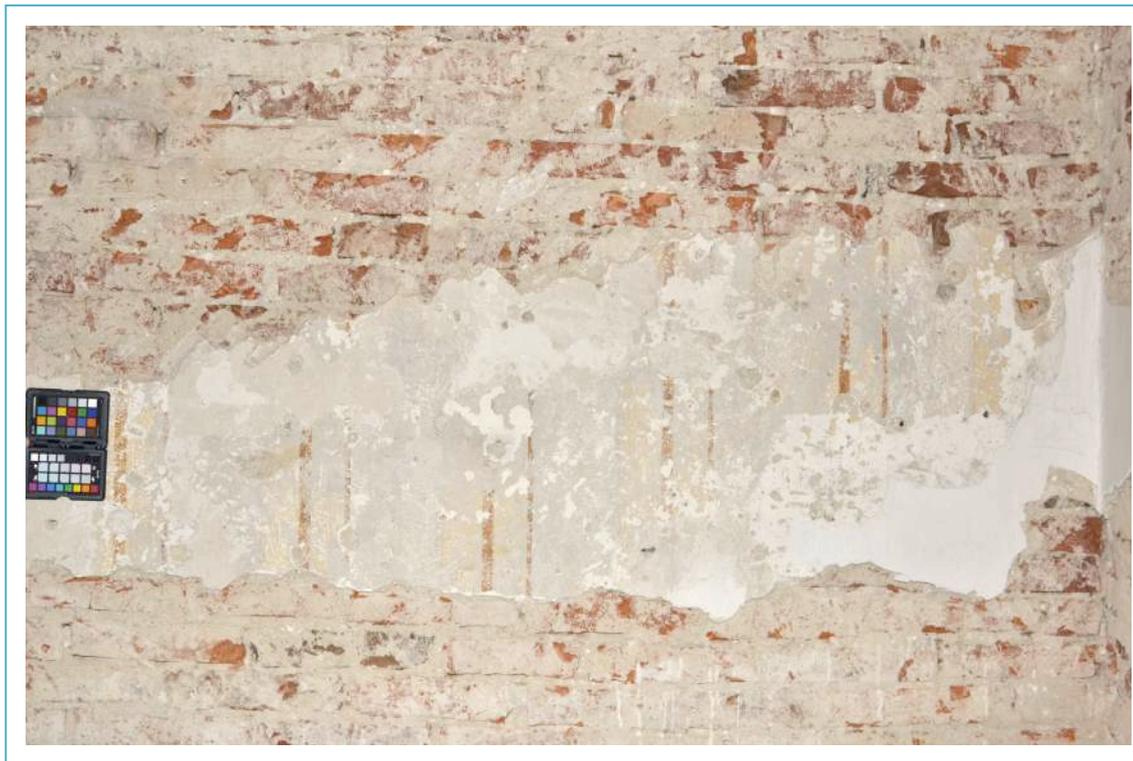
During the reign of Stanisław August, the building fulfilled the role of a water reservoir and as a dwelling. On the ground floor were three chambers for the royal service, as evidenced by historical documents and relics displayed at the exhibition: wall polychromes, heating devices and a wooden gutter used to drain water from the courtyard.

Image No. 11, Ground floor – wall polychromes, photo by Marta Boguta

Another conservation challenge was to highlight the polychromes, both the original and reconstructed layers, using historical techniques and binding materials. In two rooms, the decoration of the walls was reproduced and the original relics of 18th-century polychromes were highlighted.

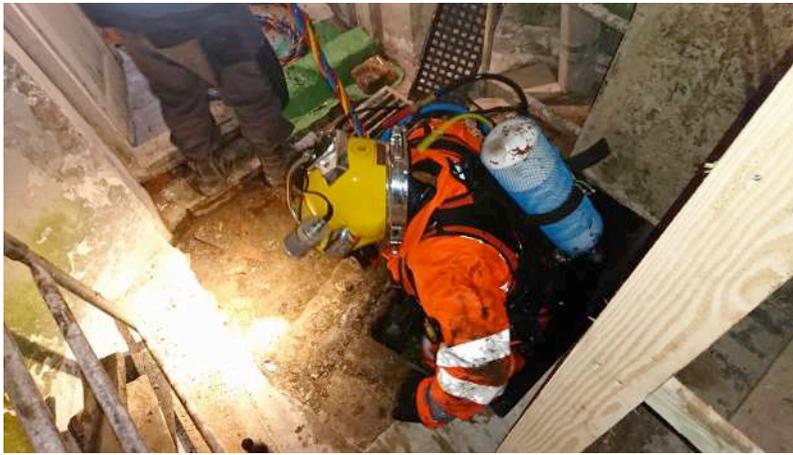
- Architectural and conservation studies of the above-ground part of the building.
- Non-invasive archaeological studies of the surroundings.
- Measurements of air pollution and resistance tests of the water reservoir's vault, including underwater exploration of its interior by divers.
- A research survey of written and iconographic sources (Polish and foreign) was performed.

*Image No. 12, Underwater exploration,
photo by Maciej Czyski*

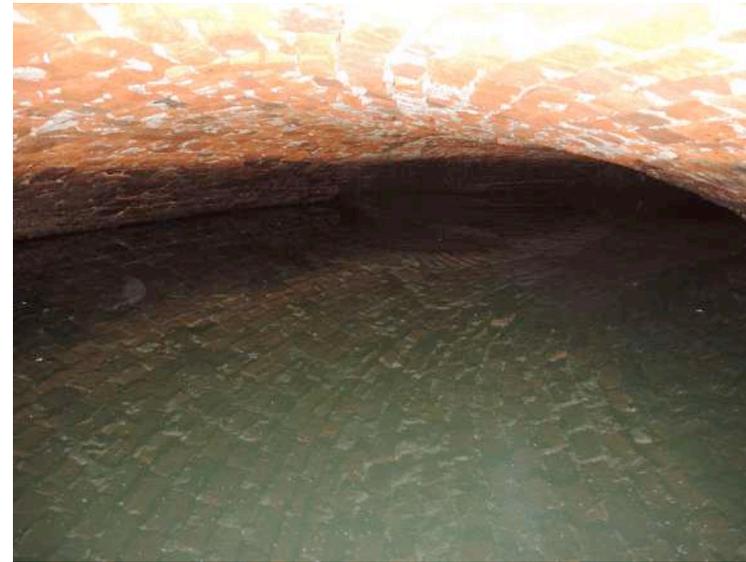
*Image No. 13, Reservoir tank underneath the ground floor,
photo by Dorota Śliwińska*

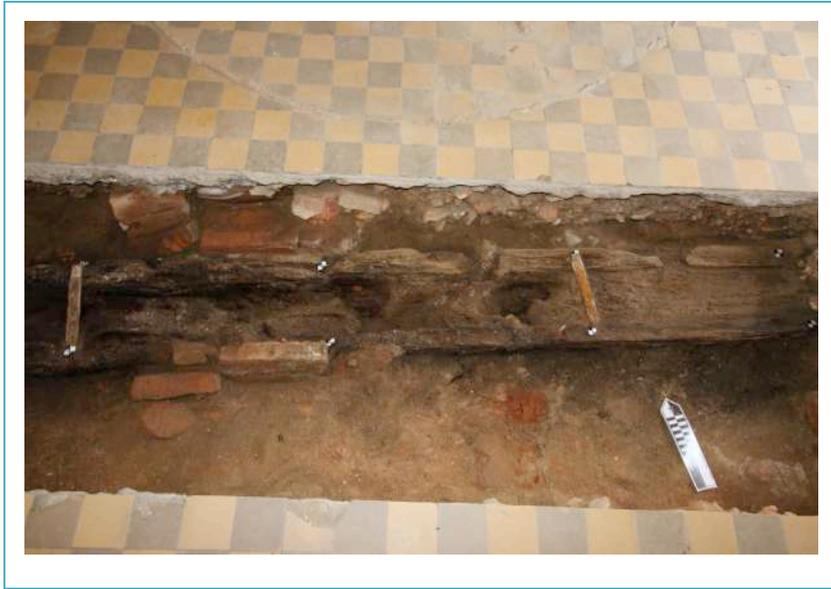
*Image No. 14, Wooden gutter found during excavation
photo by Marta Boguta*

challenge. Eventually, it was decided to display these elements in their original locations, after applying conservation measures and adapting the insulation layers or wall coverings to the elements uncovered.

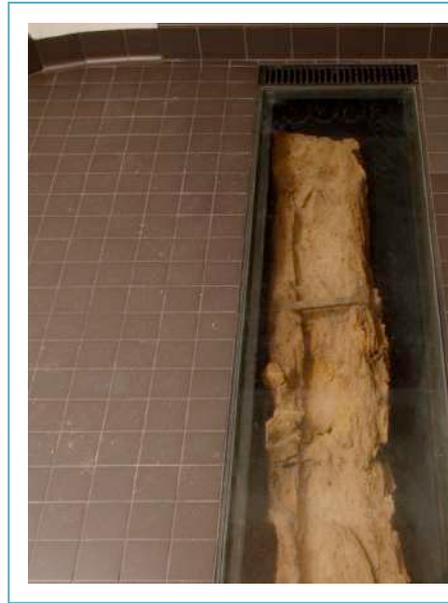
*Image No. 15, Wooden gutter after the conservation,
photo by Maciej Czyski*

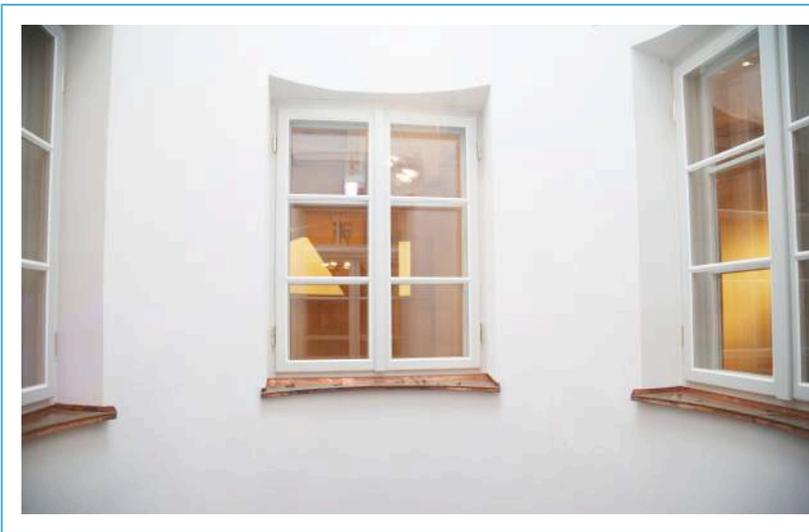
Image No. 22, Courtyard after the conservation, photo by Maciej Czyski

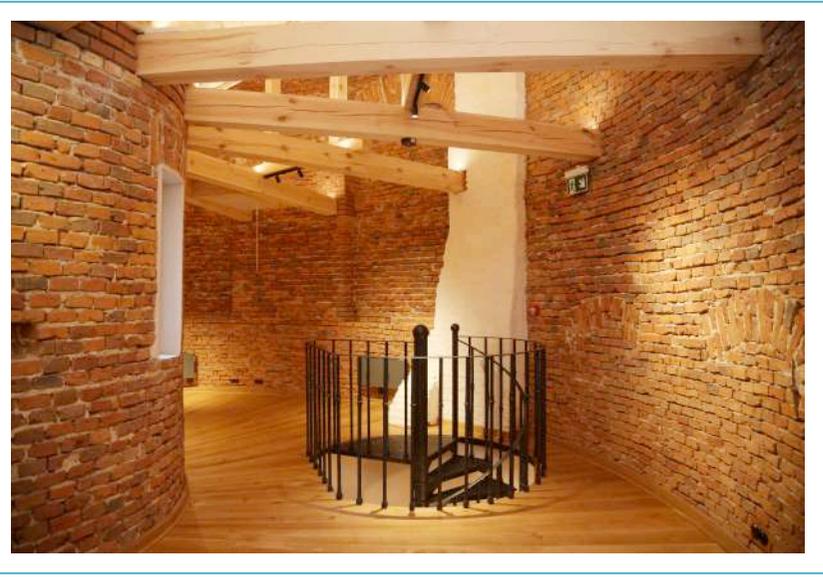
Images No. 24, 25, First floor after the conservation, photo by Maciej Czyński

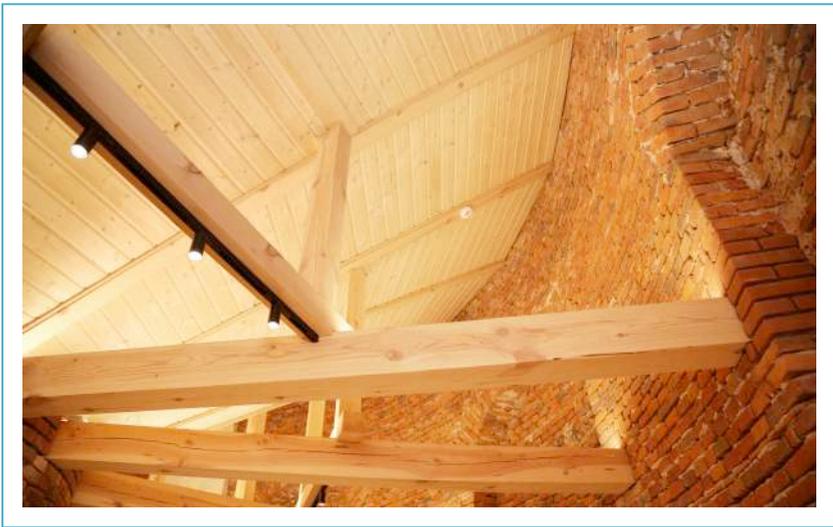
Image No. 26, Roof truss after the conservation, photo by Paweł Czarnecki
