BALTIC REGION HERITAGE COMMITTEE

Good practices on built heritage conservation/restoration

S:t Gšrans gymnasium, Stockholm, Sweden.

S:t Gšrans gymnasium (S:t Gšran high school), Stockholm. Completed 1960 and rebuilt 2015-18 to accommodate student housing and a preschool.

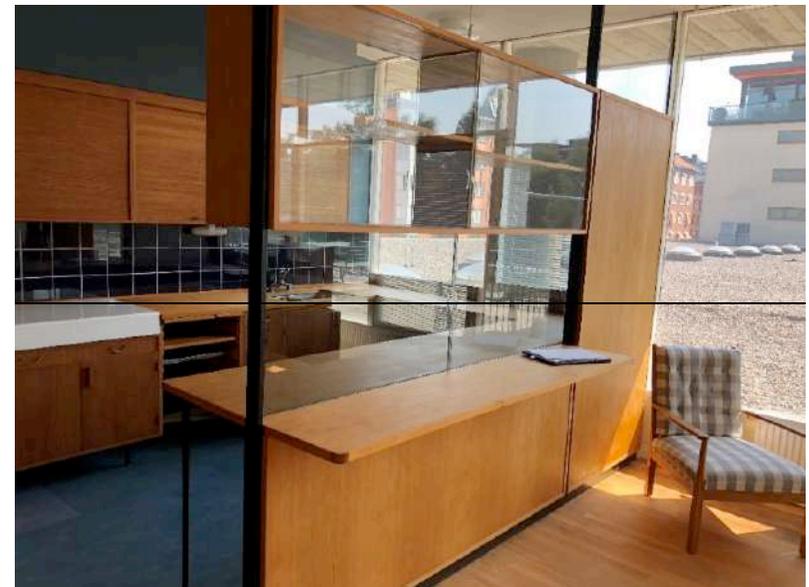
(Right): The kitchen in one of the apartments used for practical training, today turned into a museum. The materials and the quality in performance characterize the building. Photo: Cathrine Mellander Backman, RA€, 2021.

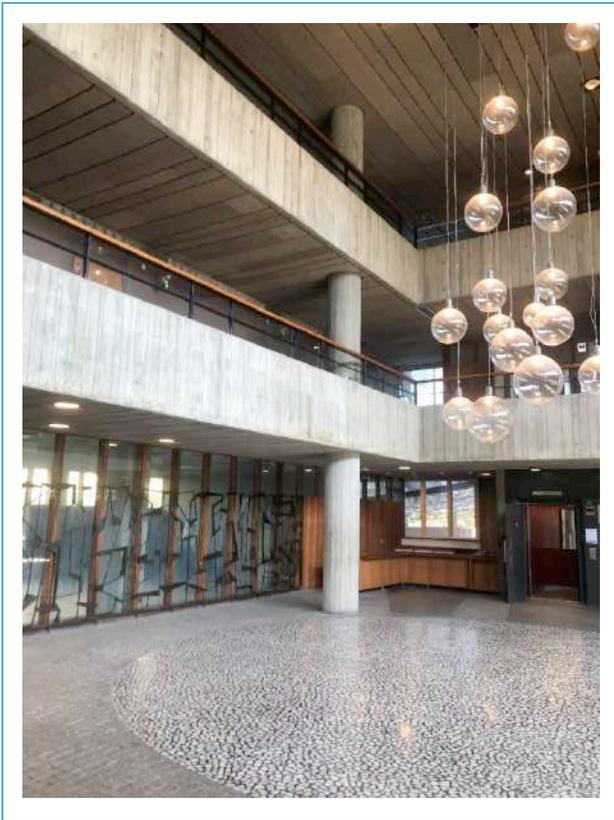
(Left): The raw concrete, the decorative ironwork, the luminaire and the floor and ground covering in the three floors high open entrance hall, all contribute to the building's unmistakable character. Photo: Eva Dahlström Rittsžl, RA€, 2021.

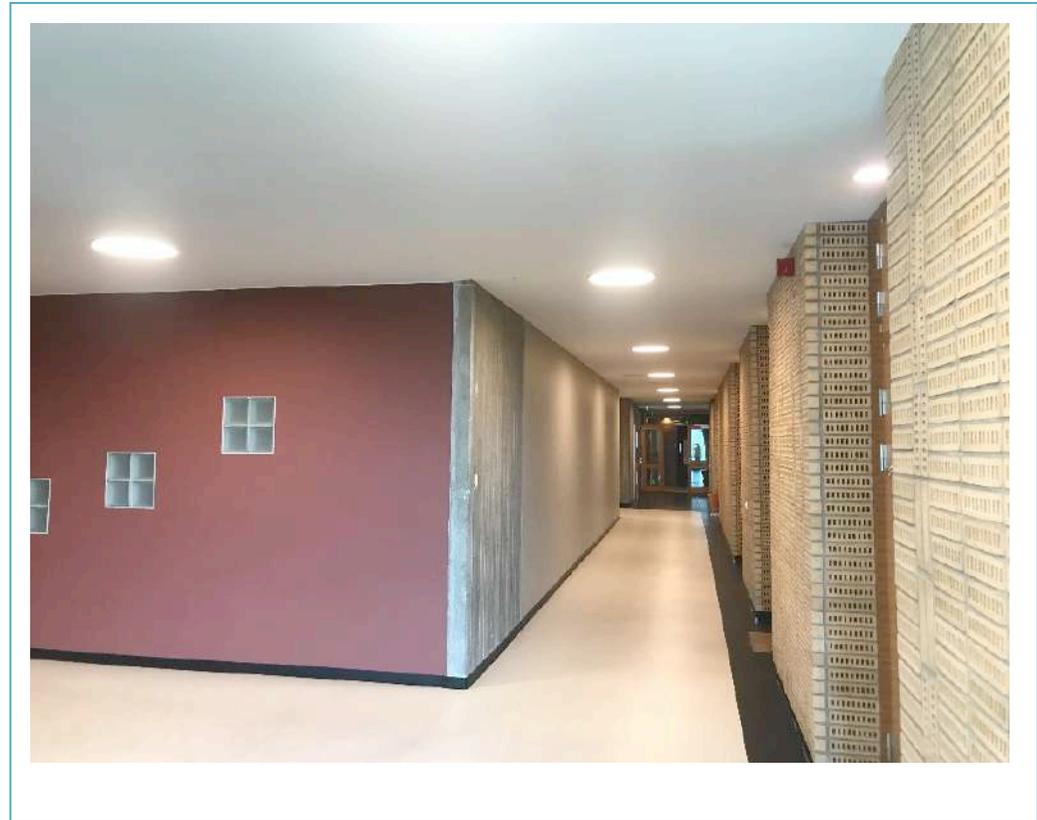
(Right): An apartment corridor with new brick walls in yellow hollow brick. Photo: Eva Dahlström Rittsžl, RA€, 2021.

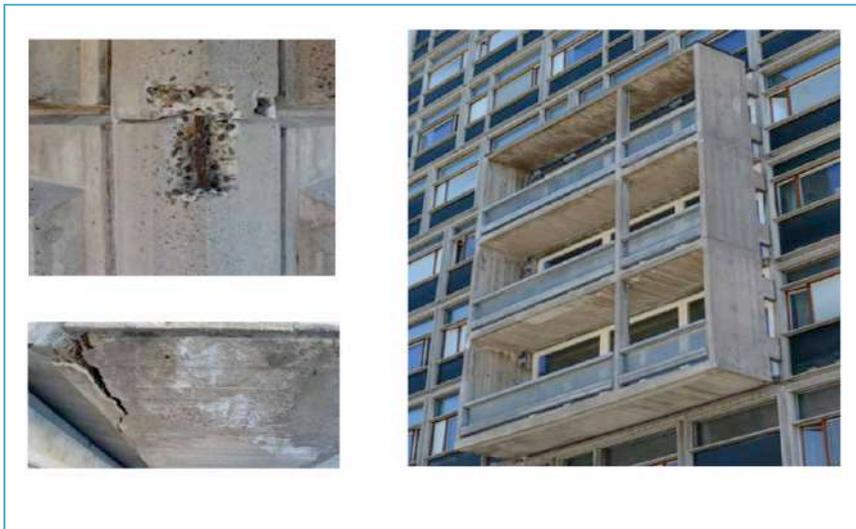
Injuries on the concrete elements and on the balconies in concrete.
Photo: Sven Olof Ahlberg.

An important goal of the work was to preserve as much of the original materials as possible and, where measures were necessary, to carry out the work with great care and adaptation to the original materials and methods. When the restoration began, the building had been empty for a number of years and the maintenance had been neglected. The damage was inventoried, photo-documented and categorized into three levels. The facades with prefabricated concrete elements with glass had extensive damage as well as the balconies. Other interventions that needed to be carried out was to restore plaster damage and leaking roofs and secure the stairs and the roof terraces. The windows, with low noise- and energy values, had to be adapted to standards of today.

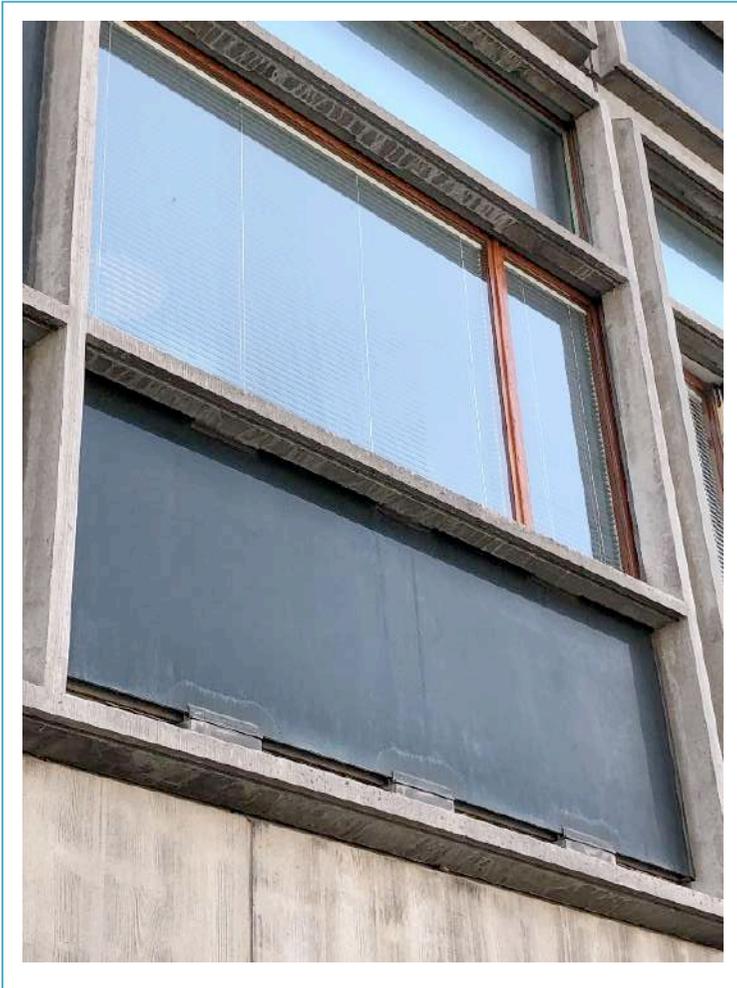
The facade with concrete elements, glass and windows. Photo: Cathrine Mellander Backman, RA€, 2021.
